NACA RM E9L07

FURTHER INVESTIGATION OF A GAS TURBINE WITH NATIONAL BUREAU OF STANDARDS BODY 4811C CERAMIC ROTOR BLADES

By John C. Freche

Lewis Flight Propulsion Laboratory
Cleveland, Ohio

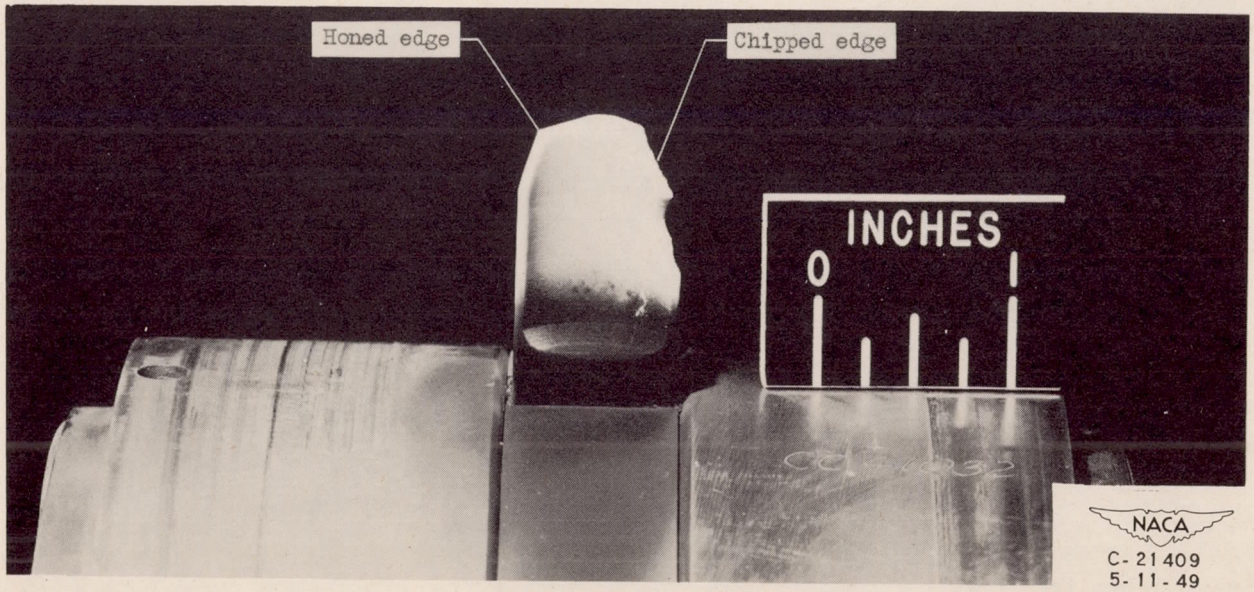
Rotating heat-shock runs. - Blade assembly 1 was subjected to a series of heat-shock cycles at tip speeds up to 737 feet per second. The minimum-shock cycle was a change in gas temperature from 300° to 1200° to 300° F in 5 minutes. The rate of inlet-gas temperature increase was equal to approximately 9° F per second and the rate of inlet-gas temperature decrease was equal to approximately 9° F per second. The maximum-shock cycle was a change in inlet-gas temperature from 300° to 1800° to 300° F in 2 minutes. The rate of inlet-gas temperature increase was equal to approximately $37\frac{1}{2}$° F per second and the rate of inlet-gas temperature decrease was equivalent to approximately $37\frac{1}{2}$° F per second. The blades successfully withstood the complete series of heat-shock cycles except for a small part of the leading edge of one blade. Inspection of the turbine after the first series of cycles at a turbine tip speed of 263 feet per second revealed that a small part of the leading edge of one blade had chipped off. A close-up of this blade still assembled in the turbine wheel after the entire series of runs had been completed is shown in figure 4. All four blades used in this series of heat-shock cycles had already been chipped during previous endurance runs, but the rough edges had been honed prior to assembly in the turbine. It is possible that the chip lost during the heat-shock tests was the result of a previously undetected crack. Because no other breakage occurred Body 4811C blades evidently have a greater heat-shock resistance under load than was indicated by operation in reference 2.

2. Blade assembly 1, which contained blades subjected to previous endurance operation at 1800° F, withstood complete heat-shock cycles in which the gas temperature was varied from 300° to 1800° to 300° F at various tip speeds up to 737 feet per second, which is equivalent to centrifugal blade loads of one-half design value. Only the leading edge of one blade was chipped during these runs.

Figure 4. - Close-up of turbine blade showing leading edge chipped during rotating heat-shock runs with blade assembly 1.

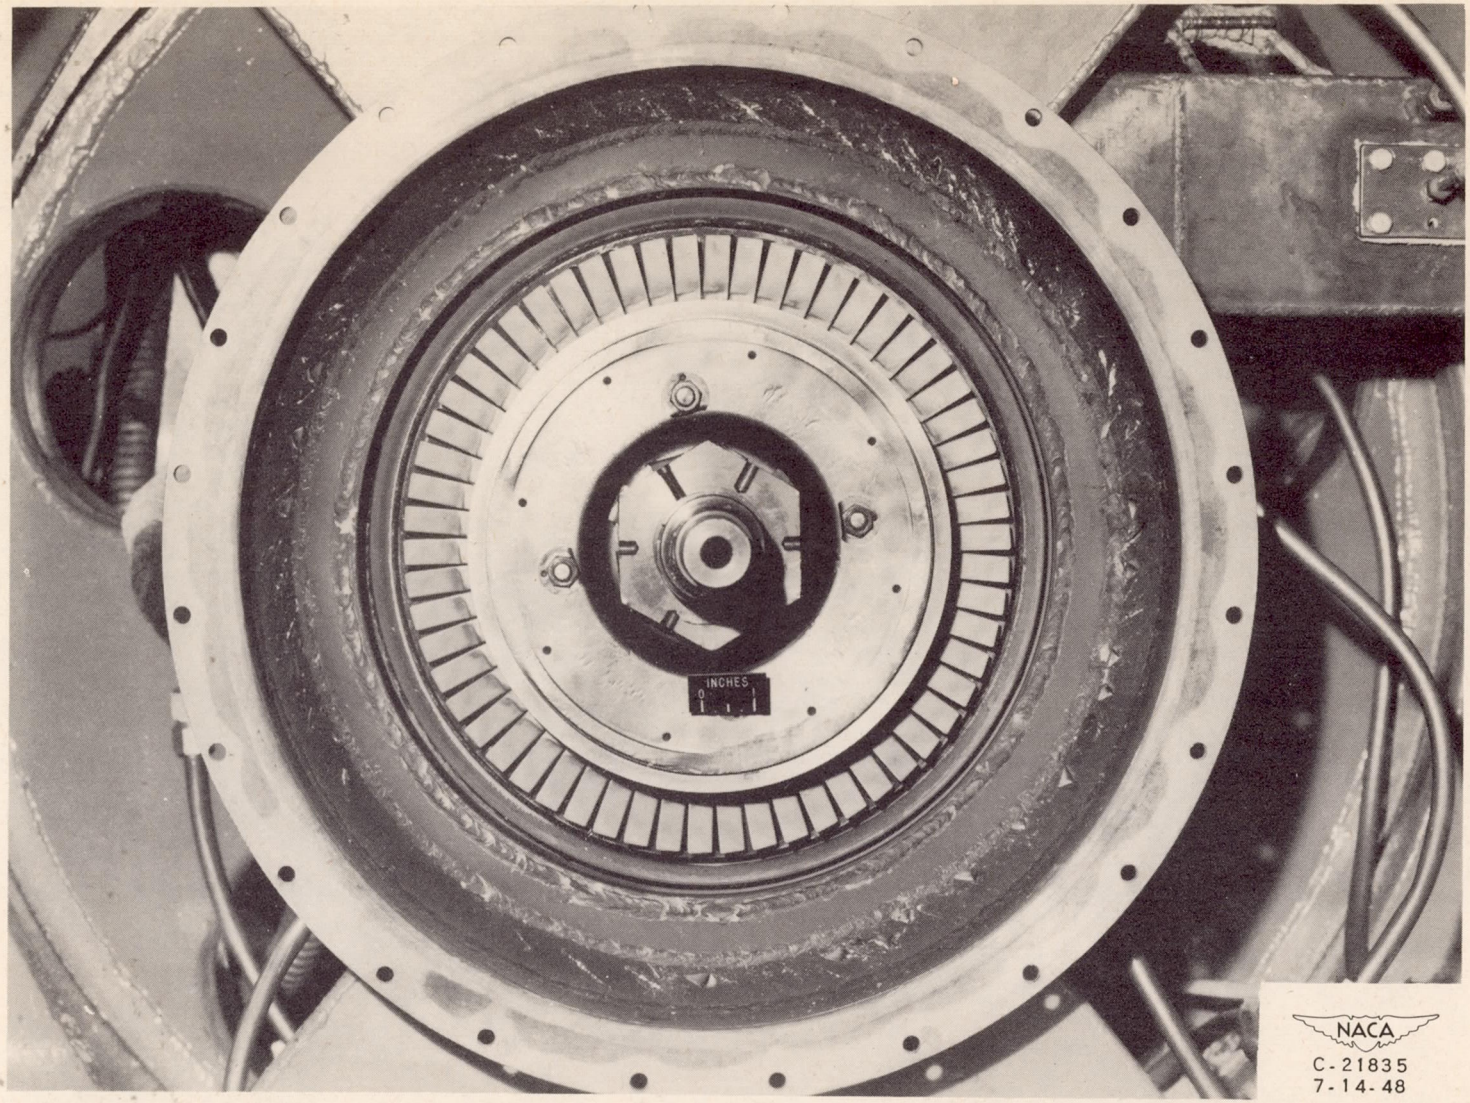
Blade assembly 4 consisting of 58 new Body 4811C blades was operated for 60-minute intervals at 1800° F and various tip speeds up to 842 feet per second and at 2000° F at a tip speed of 631 feet per second without any damage to the blades. The turbine rotor and blade assembly after this period of operation is shown in figure 5. These runs were essentially endurance tests to determine the limiting conditions attainable with Body 4811C blades. The minimum operating conditions set for this run were the same as the maximum operating

conditions attained in the earlier investigation (reference 2). When the turbine was disassembled for inspection, it was found that the metal disks had become distorted.

Figure 5. - Turbine rotor with Body 4811C blades in rig supporting structure after operation at turbine tip speed of 842 feet per second (16,000 rpm) and inlet-gas temperature of 1800° F.
